Re: Sanford, Edenville, Smallwood
P-2785, P-10808, P-10810
Final Report Apron Repair

**BOYCE HYDRO POWER, LLC
FINAL REPORT ON REPAIR OF SLAB UNDERMINING
AT**

**SANFORD P-2785
EDENVILLE P-10808
SMALLWOOD P-10810
October 4, 2011**

WORK REPORT

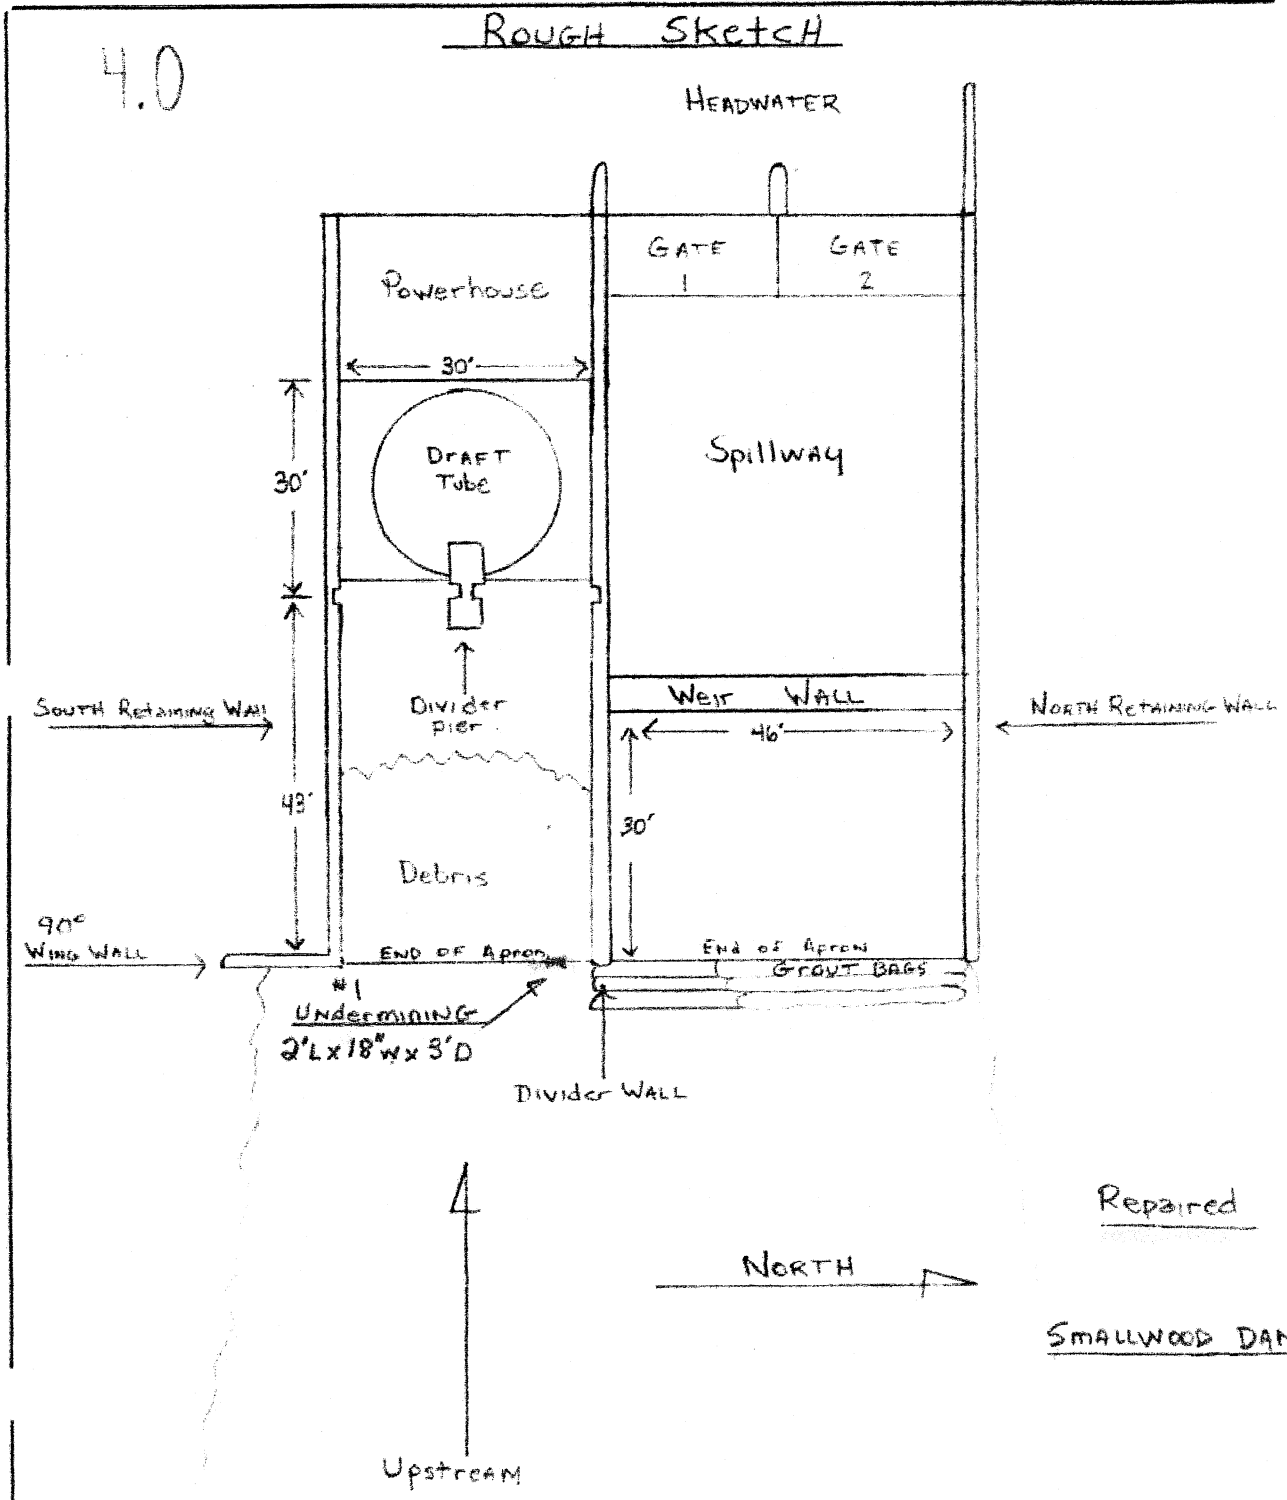
SMALLWOOD DAM

- Defect- Undermining 2ft. Long x 18in. Wide x 3ft. Deep
- Location- On the powerhouse downstream concrete scour slab, 5 ft. South of the concrete divider pier. (See rough sketch)
- Repair- (6) 60lbs. bags of Quickcrete ready-mix staked in place with re-bar pins.

#1 UNDERMINING
2' L x 18" W x 3' D

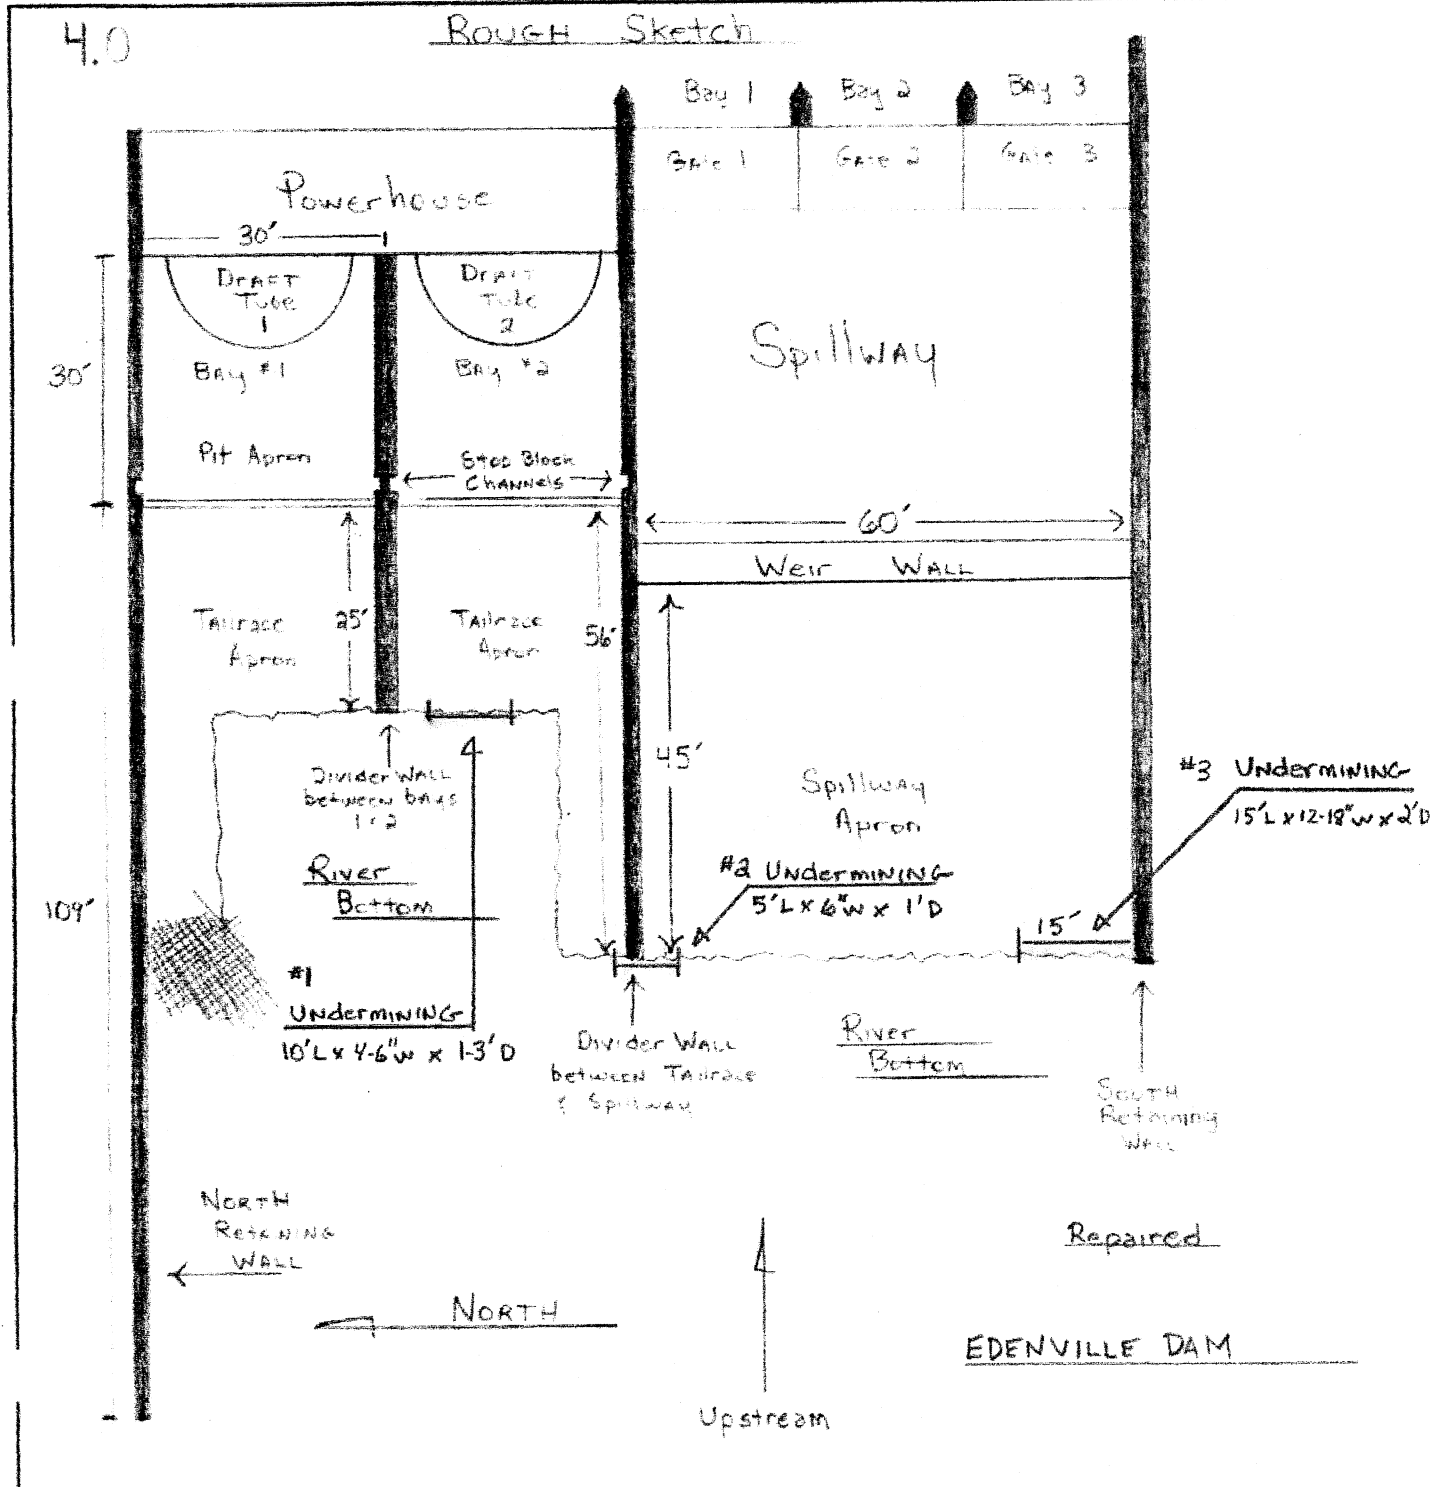
- Defect- Undermining under grout bag--- 5 ft. long x 6 in. wide x 1 ft. deep.
- Location- Directly downstream of the divider wall between the powerhouse and spillway. (See rough sketch)
- Repair- (11) 60 lbs. bags of Quickcrete ready-mix staked in place with re-bar pins.

- Defect #1- Undermining under grout bag---10 ft. long x 4-6 in. wide x 1-3 ft. deep
- Location- Powerhouse downstream concrete scour slab, 3 ft. south of the concrete divider wall between bays #1 & #2 (See rough sketch)
- Repair- (1) 10 ft x 3 ft. concrete filled grout bag. (Grout bag filled w/approx 2 yds.)

- Defect #2- Undermining of concrete scour slab---15 ft. long x 12-18in. wide x 2ft. deep
- Location- On the spillway downstream concrete scour slab from the South retaining wall to 15 ft. North. (see rough sketch)
- Repair- (1) 15ft. x 3ft. concrete filled grout bag. (Grout bag filled w/approx. 3.5 yds)

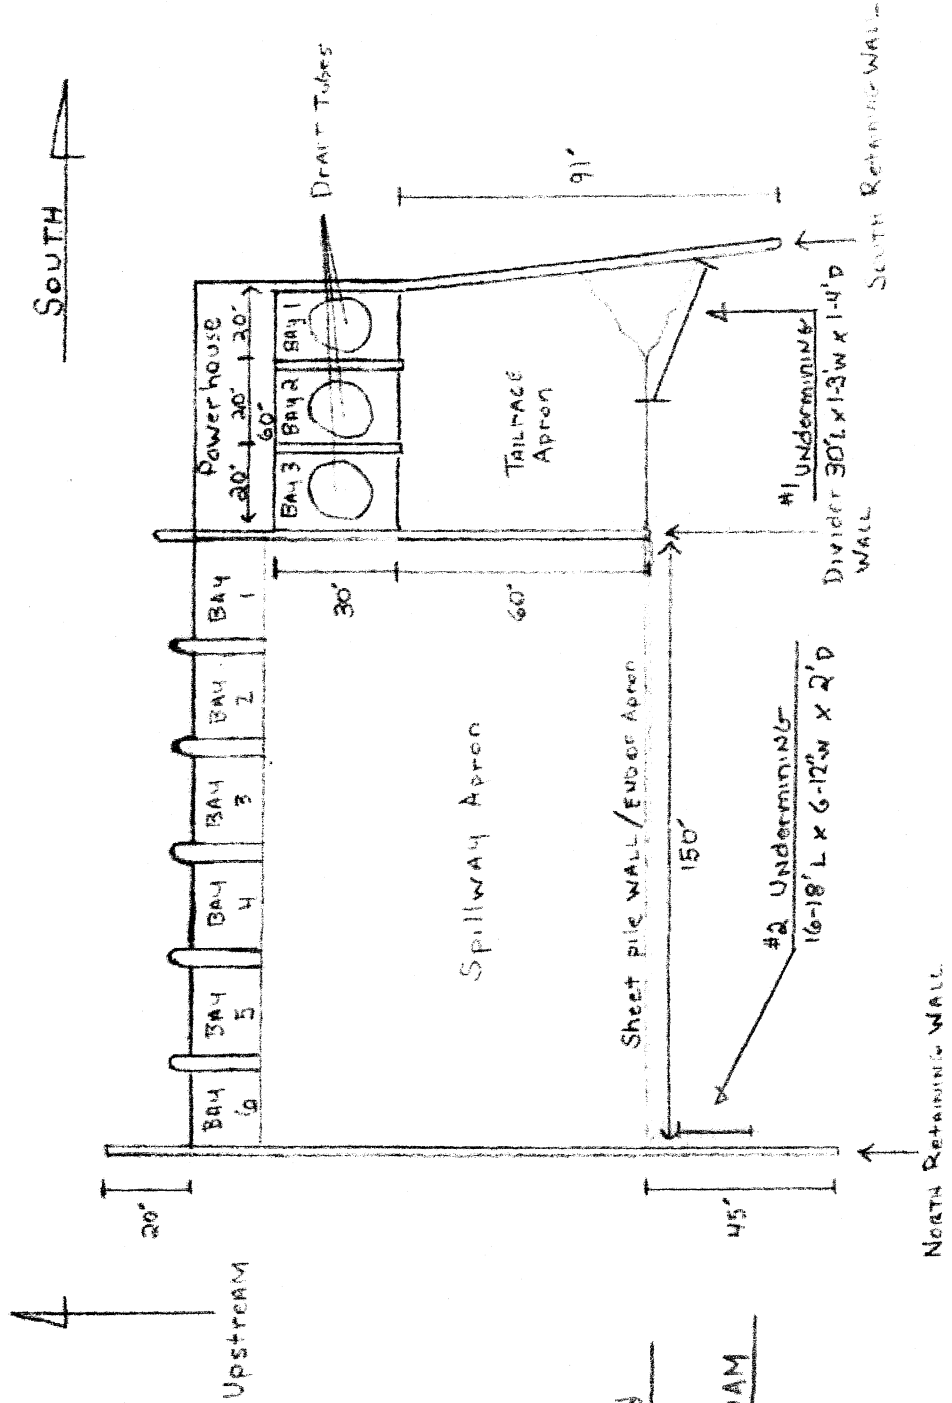
SANFORD DAM

Defect #1- Undermining of concrete scour slab- 30 ft. long x 1-3 ft. wide x 1-4 ft. deep

Location- On the powerhouse downstream concrete scour slab, from the South retaining wall to 30 ft. North. (see rough sketch)

Defect #2- Undermining under sheet pile- 16-18 ft. Long x 6-12 in. Wide x 2 ft. Deep

Location- Stub sheet pile wall placed approx. 2 ft. South out paralleling the North concrete retaining wall from 8-24 ft. downstream of the spillway scour slab. (see rough sketch)

Repair- (4) 10ft x 3 ft. wide concrete filled grout bags. (Grout bags filled w/approx. 5.5 yds.)

Repair- (3)-10 ft. x 3 ft. wide concrete filled grout bags. (Grout bags filled w/approx. 3.5 yds.)
