BOYCE HYDRO POWER LLC

**RE: Edenville Dam P-10808
Concerns Regarding Winter Gate Operations For Reservoir Level Control**

Boyce Hydro Power, LLC
Photos of Spillway Gates by Greg Uhl, Assistant Chief Operator
December 27, 2017
Page 1 of 3

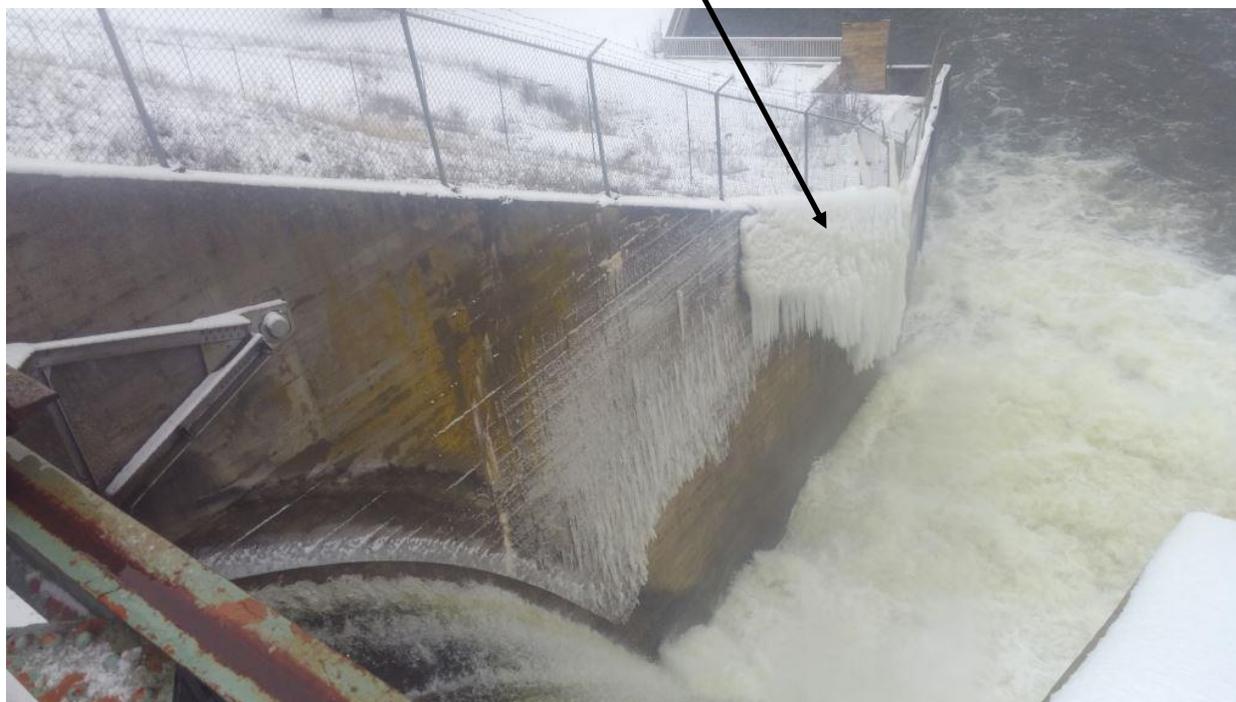
Edenville Dam, Tobacco River Spillway: View of Left Side Gate Oriented Downstream (22 December, 2017)

Ice formation on sidewalls will increase and eventually encrust gate side seals as temperatures drop and remain below freezing in January

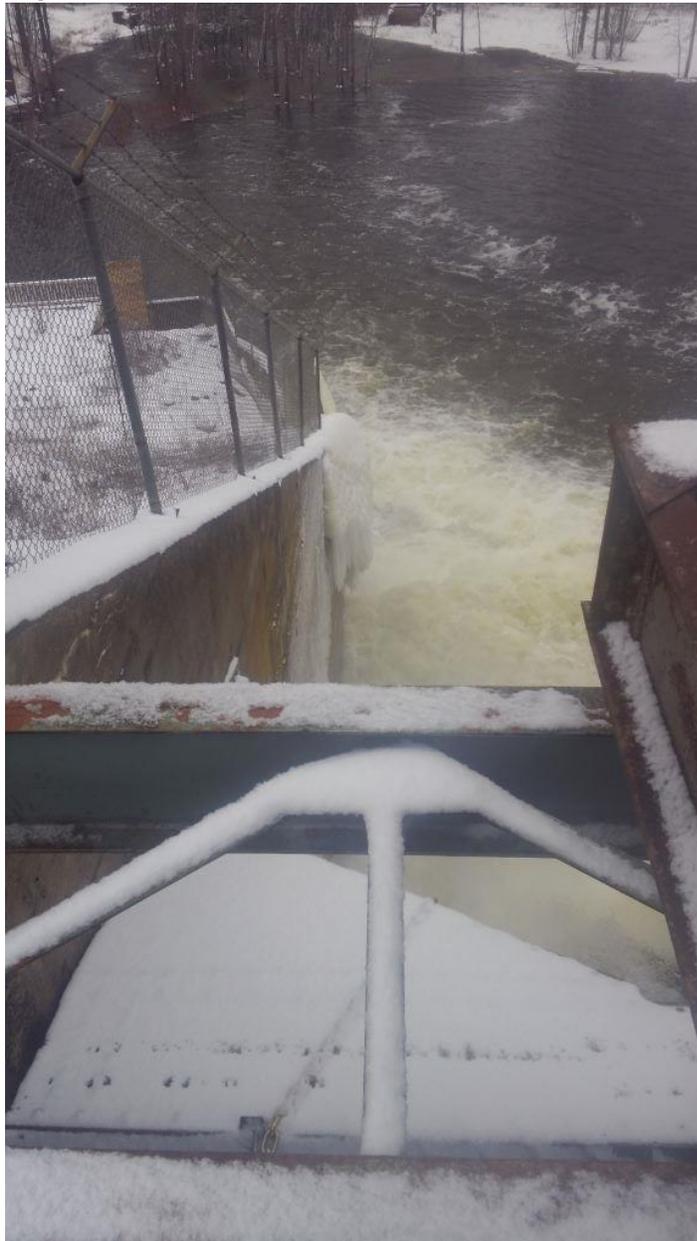
Edenville Dam Tobacco River Spillway (22 December, 2017)

Left gate as viewed from the service catwalk, looking downstream. As freezing temperatures continue, ice builds up on the gates and side piers and eventually sealing the steel gates to the piers. Removal of ice buildup is accomplished by pressure washing the ice with a steam heated portable washer transported in the bed of a service truck. Service truck access to the spillway is on the crest of the dam which is barely 10 feet wide, and is hazardous to drive on when it is encrusted with ice.

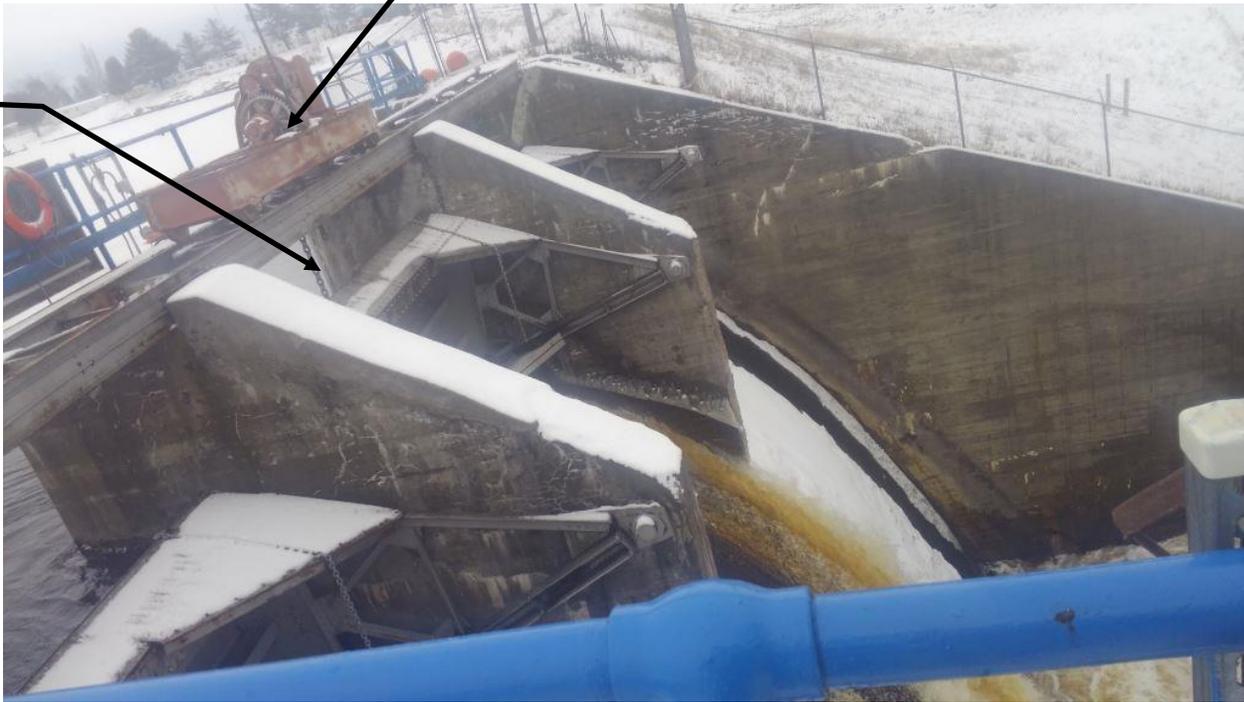
View of Edenville Dam Powerhouse Spillway Gates (22 December, 2017)

Tainter gate spill cart hoist with electric winch and chain sprocket

Hoist chain

Center gate is open and flowing water. Left and right side gates are closed with ice formations encrusting downstream rollaway slabs. As winter temperatures drop overnight, freezing begins to encrust the gate side seals and bind them to the concrete piers.

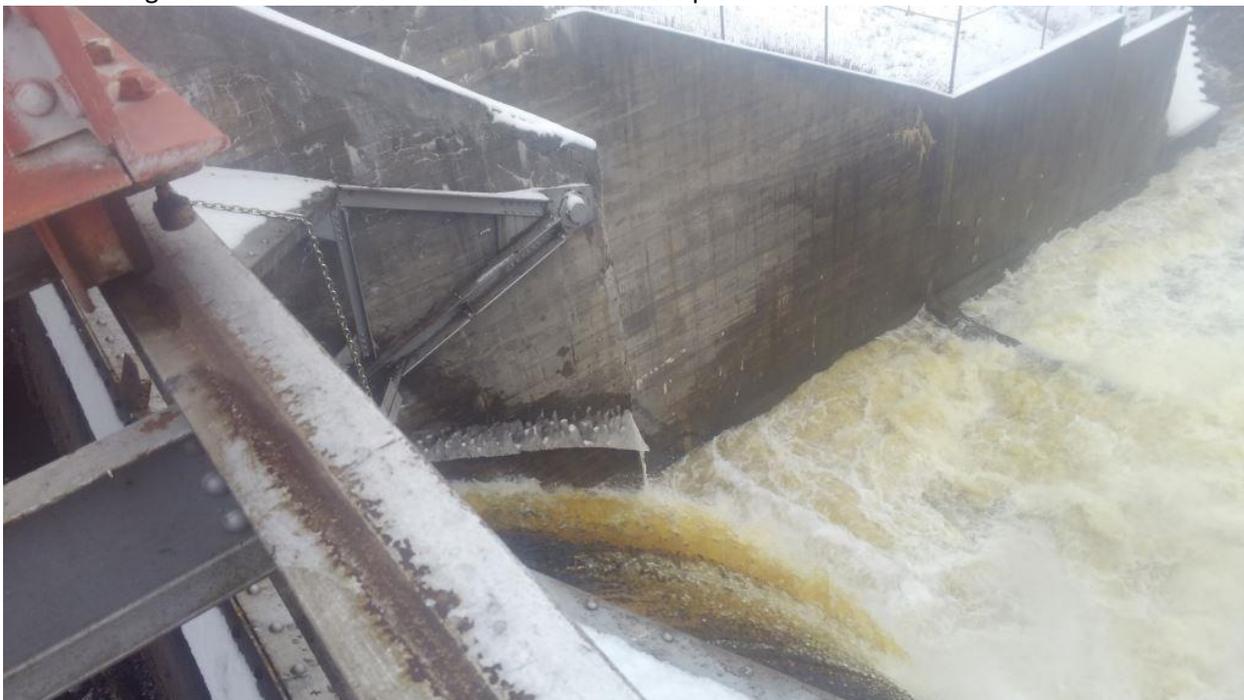
View of Edenville Dam Powerhouse center gate oriented downstream (22 December, 2017). These steel radial arm tainter gates (approximately 22' long x 10' high) are manually operated with an electric motor winch connected to a steel sprocket and hoist chain which is attached to the bottom end of the gate.
